785 Maple, 5/01/12

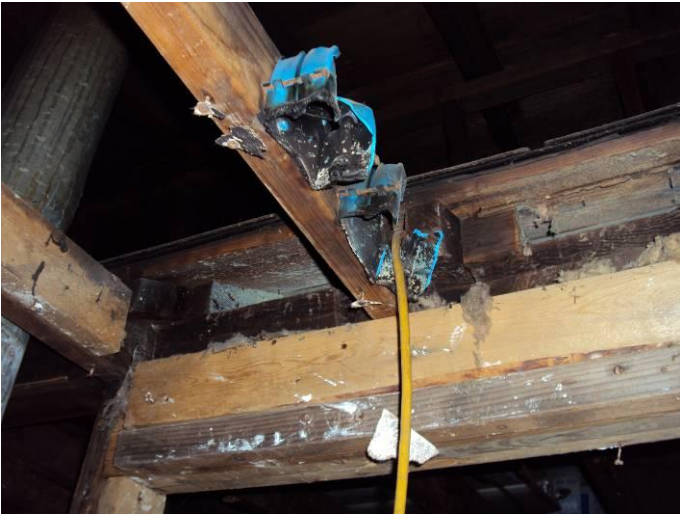
Fire damaged electrical boxes in ceiling (1st floor)

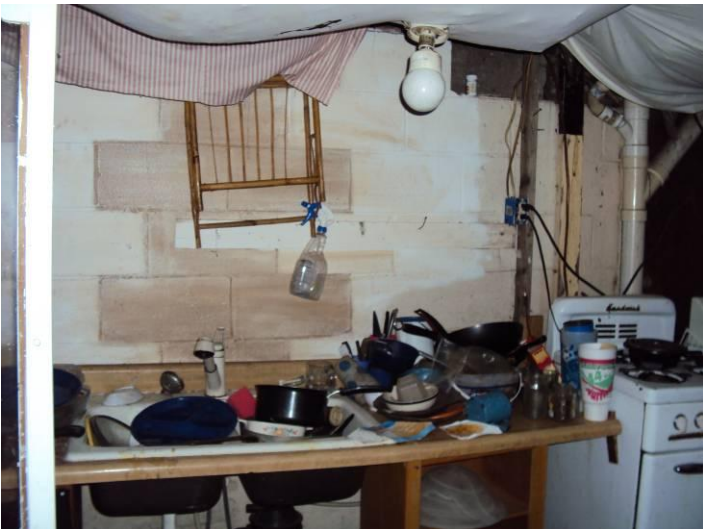
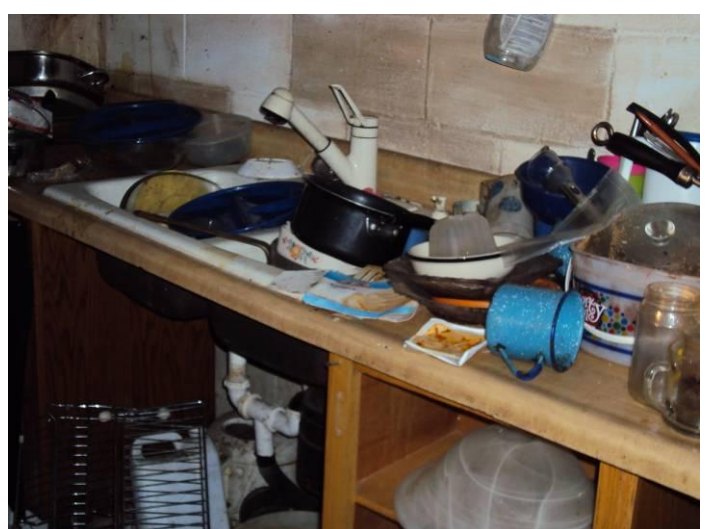
Make-shift kitchen area in basement

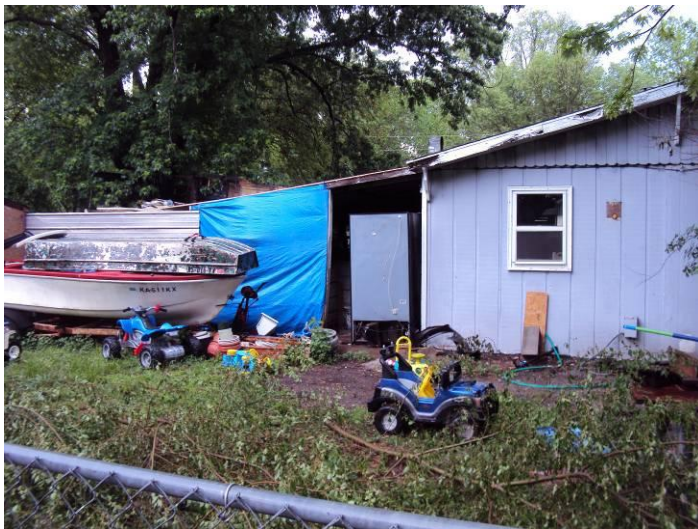
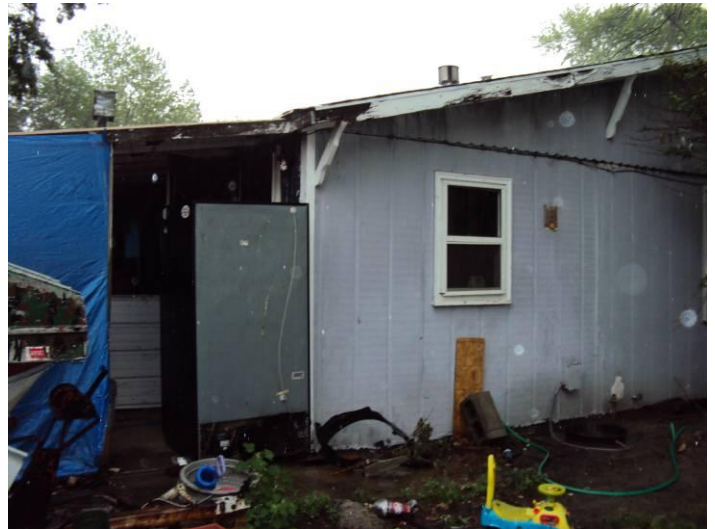
Refrigerator – plugged in and exposed to weather
