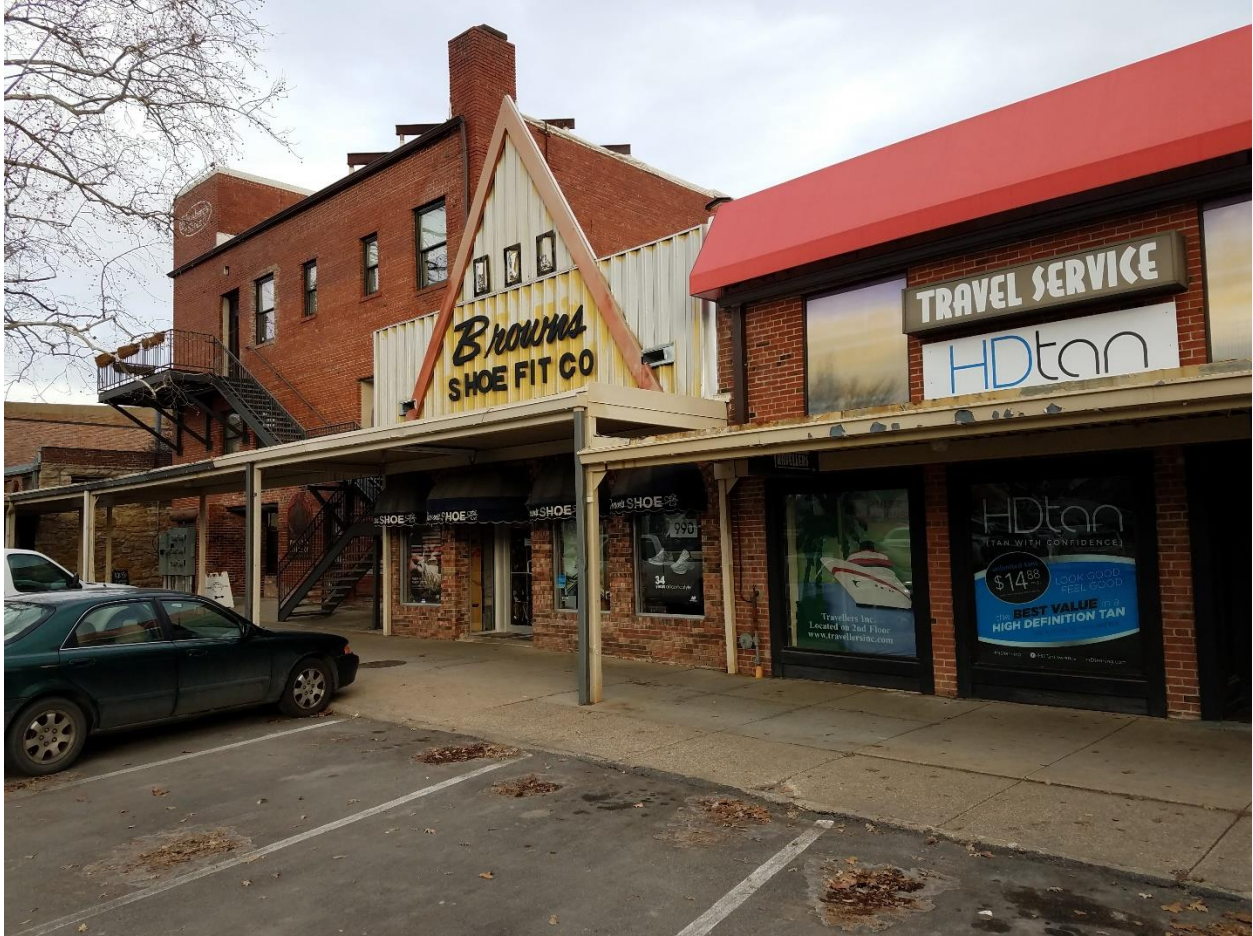
Typical Canopy sections. Gutter and Downspouts in disrepair

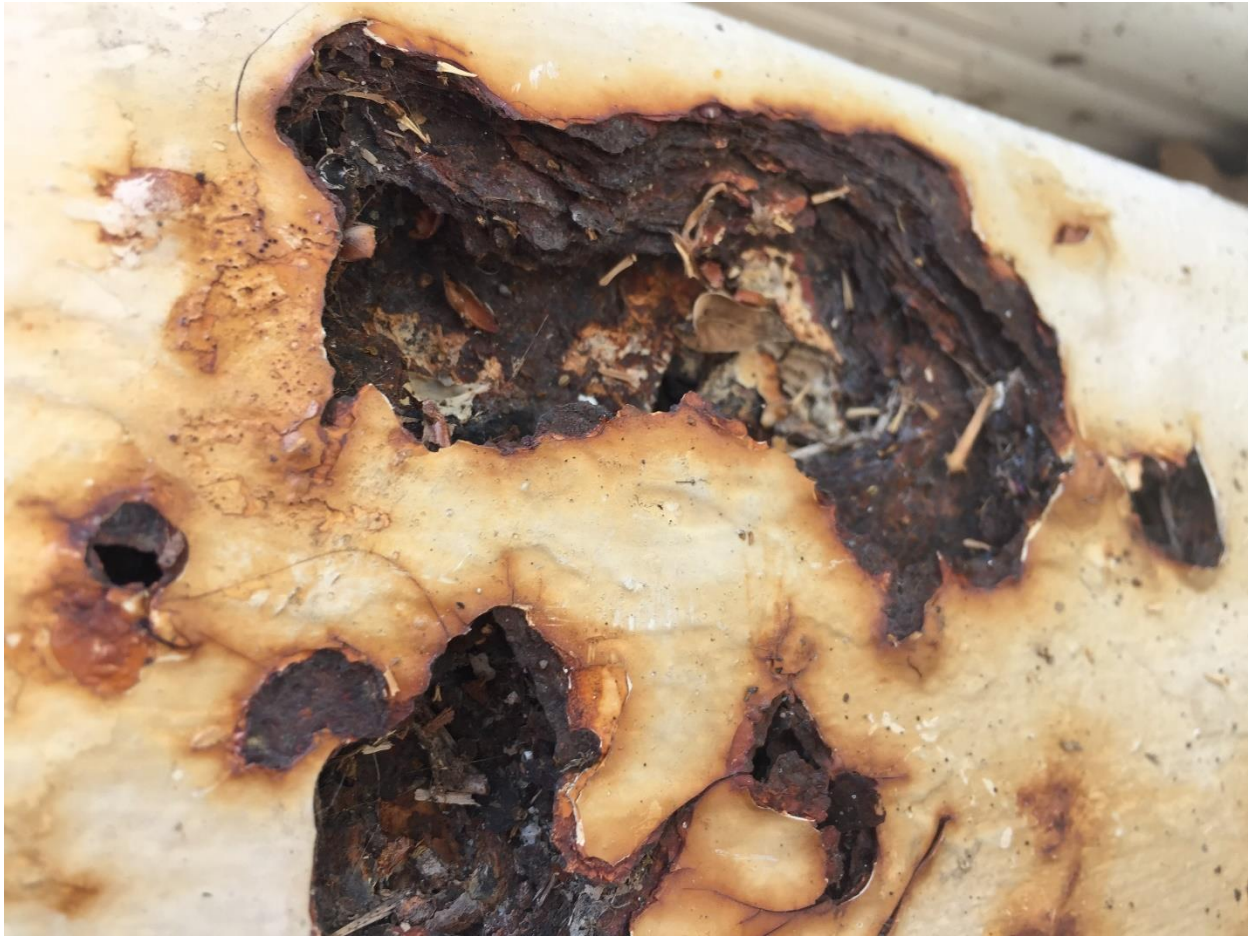
Structural steel column rusted through

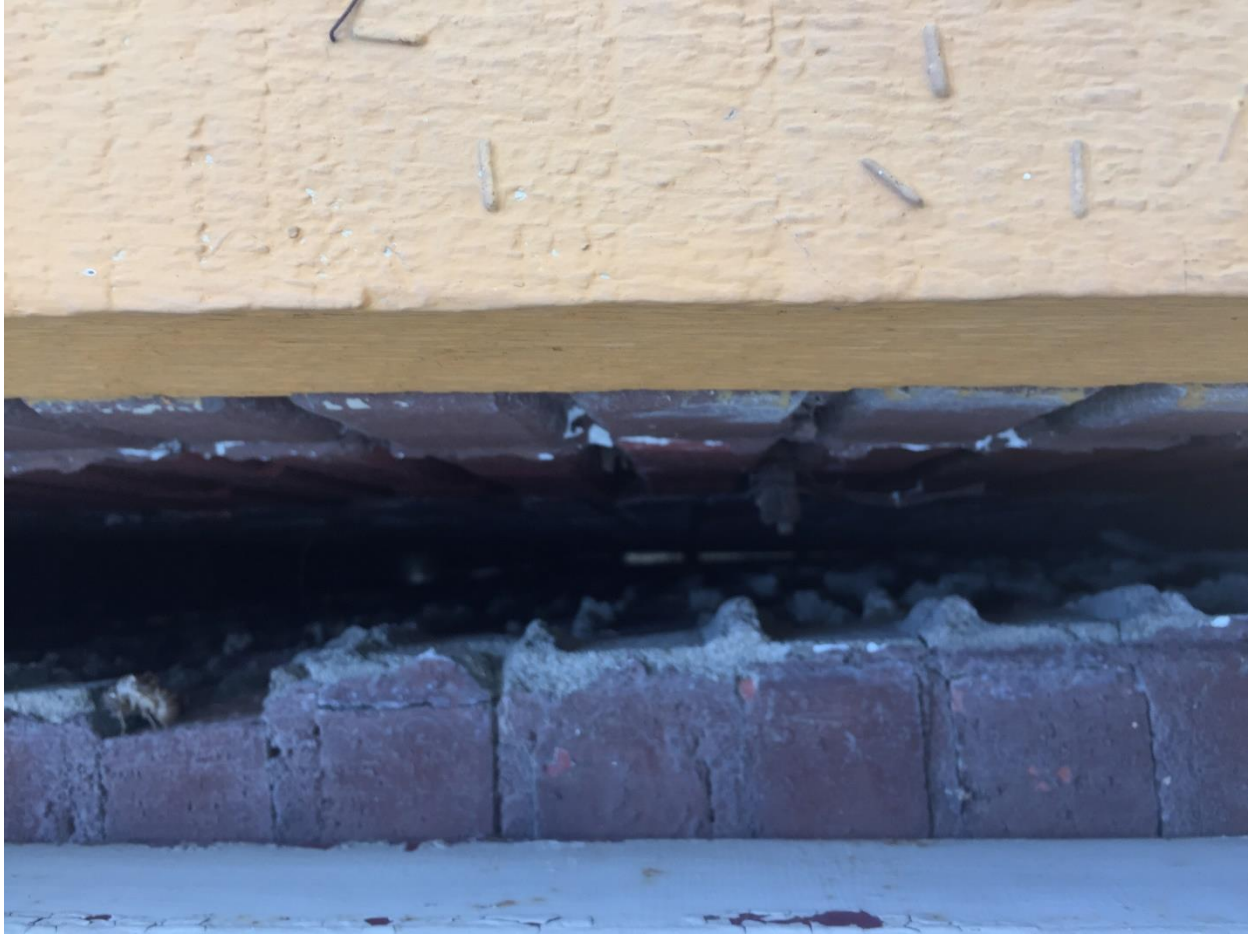
Brick Façade section separating from original structure. Structural steel members of the Canopy are the only thing keeping it from falling down (Could not rotate picture, this is vertical wall section)

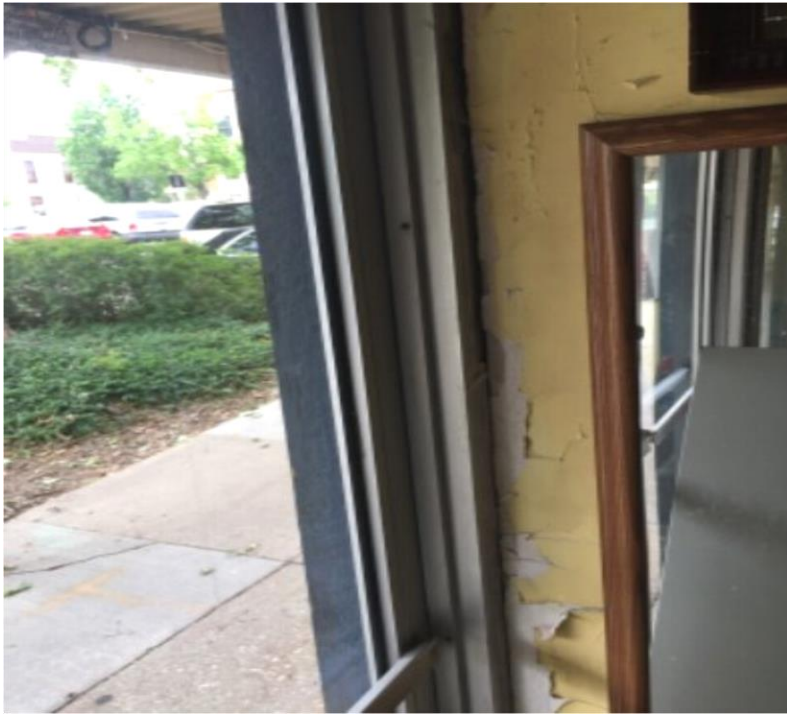
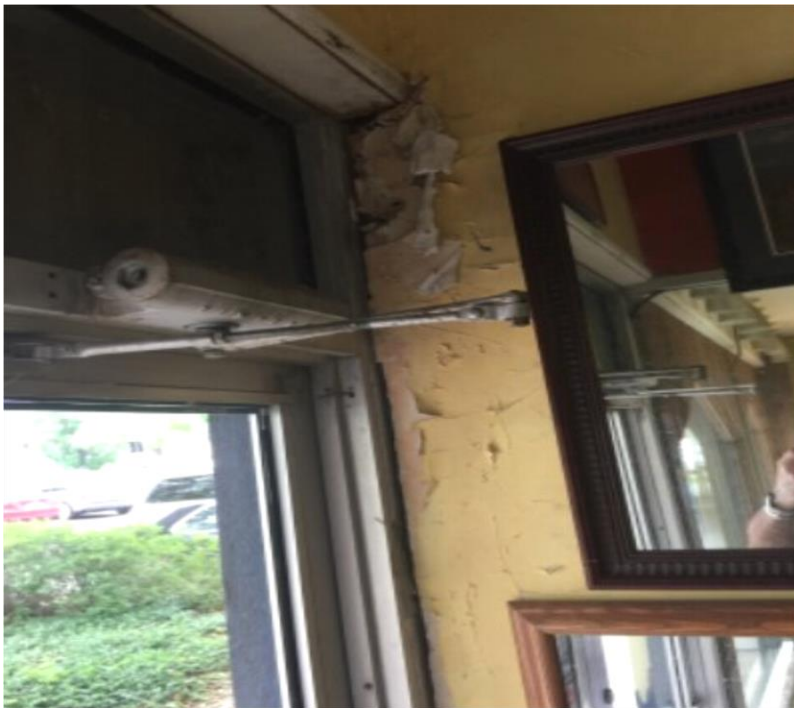
Water damage to the interior of buildings due to canopy water runoff

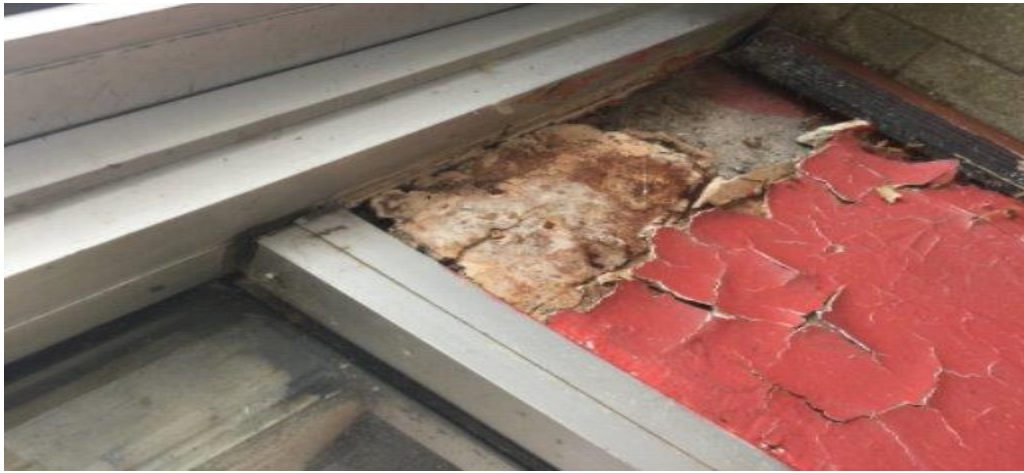
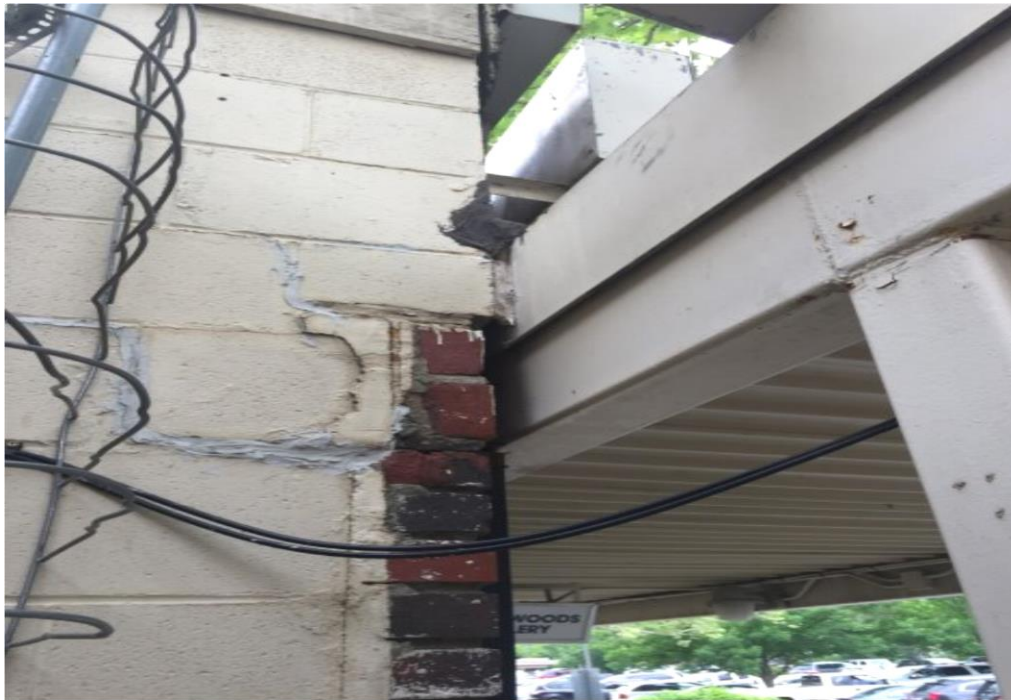
Water damage to the exterior of buildings due to canopy water runoff

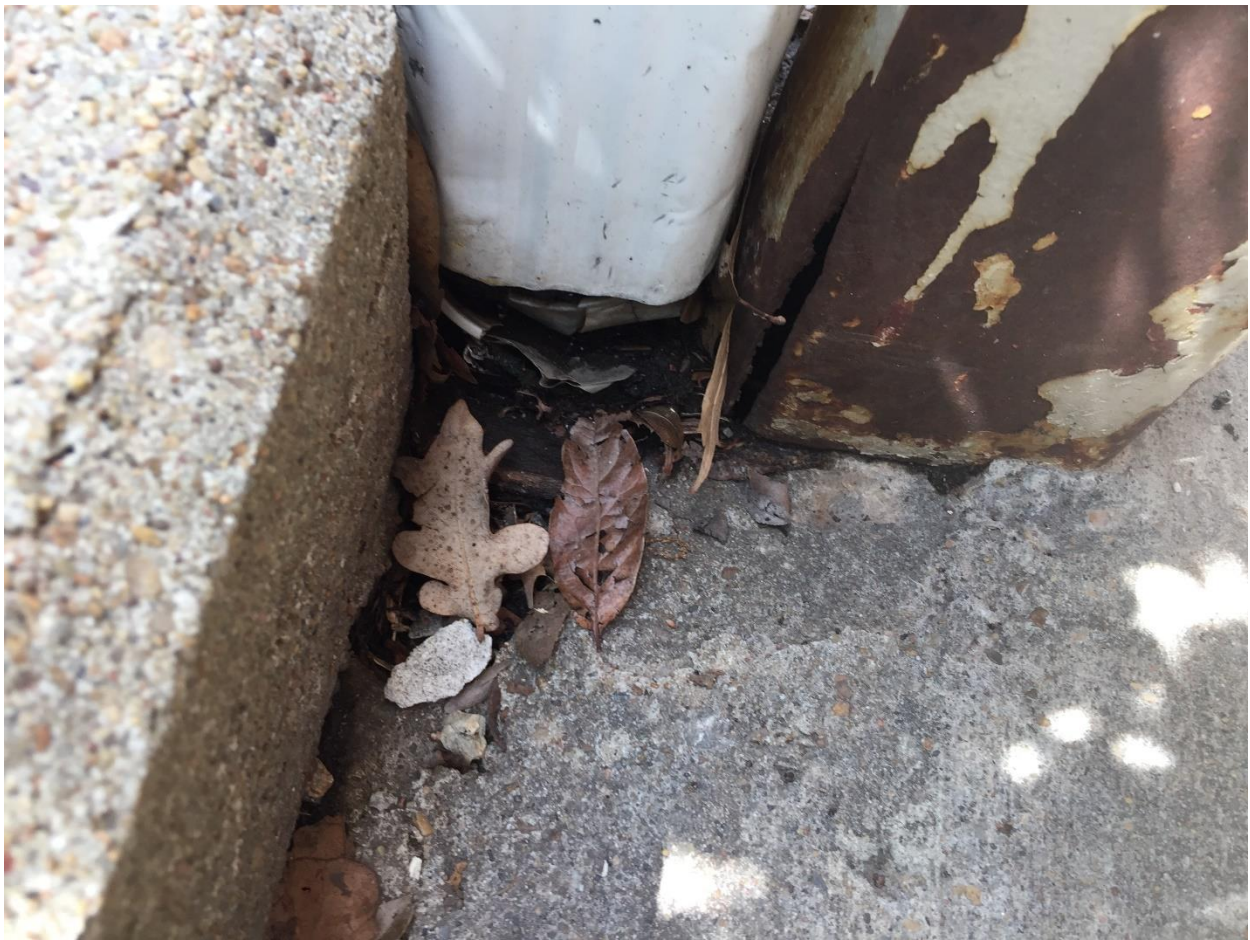
Structural steel column and storm water down spout. Structural steel cracked and rusted from freeze thaw water infiltration. Gutter and storm water inlet plugged.

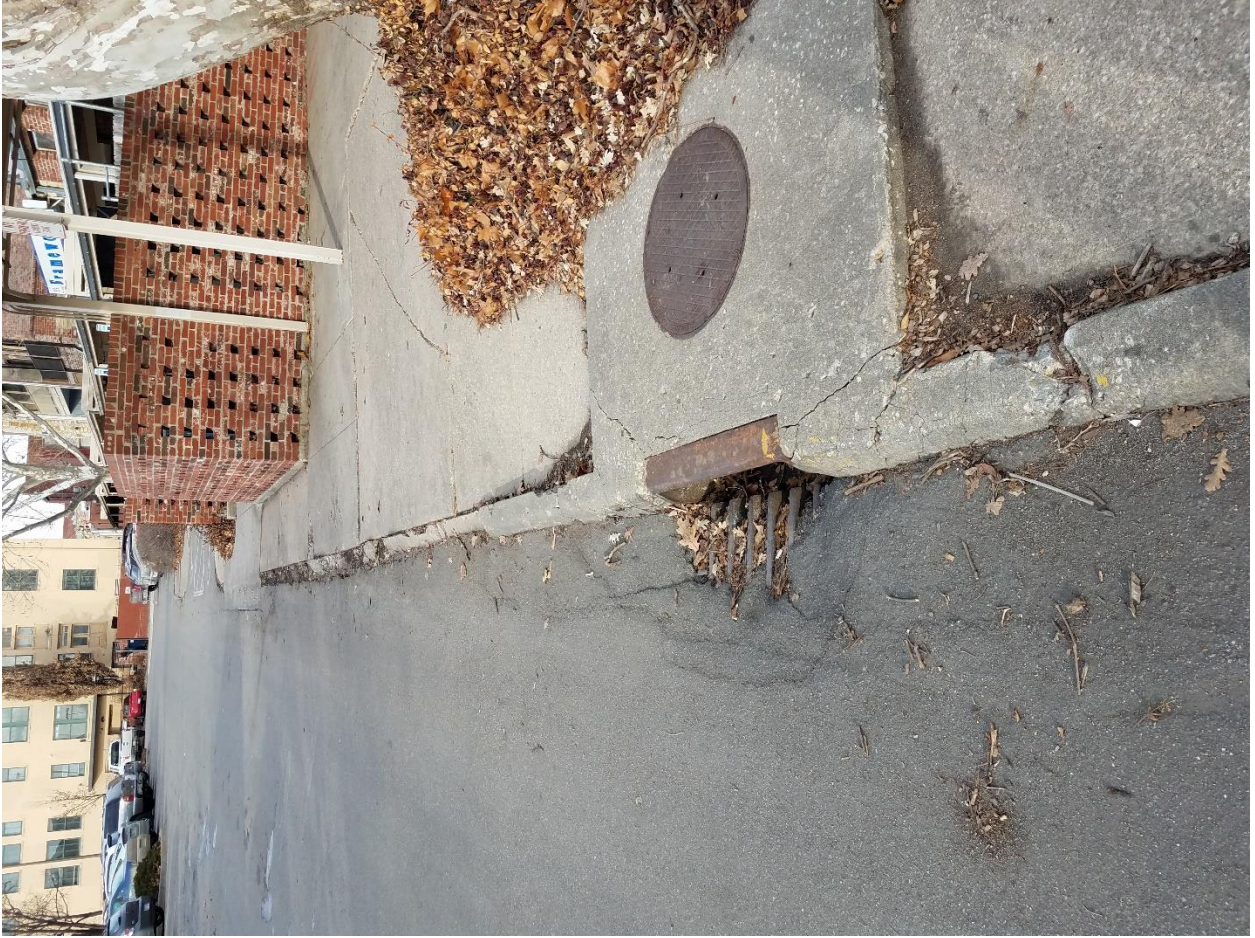
Storm water inlet with concrete settling and trip hazards

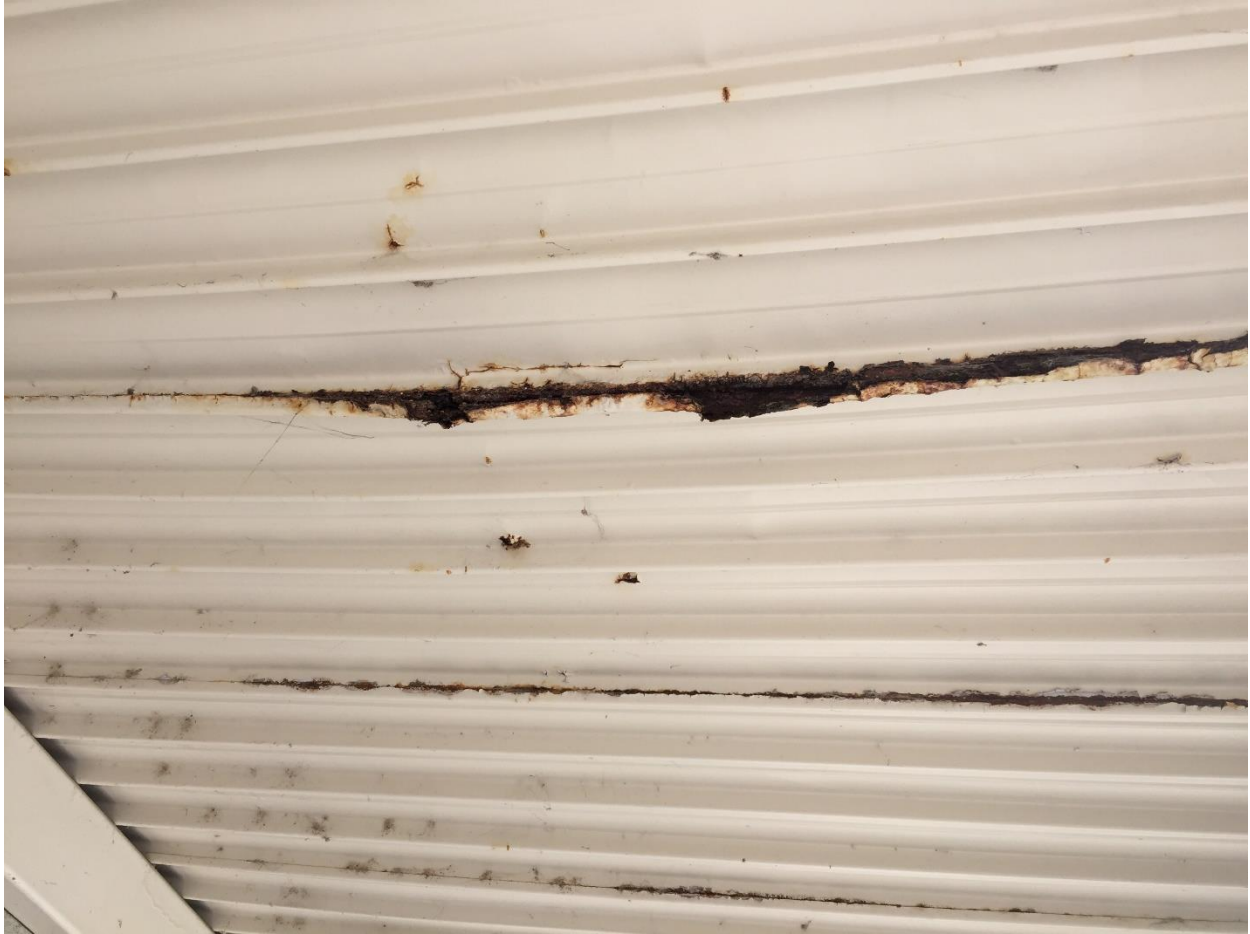
Metal roof decking rusted through and leaking water

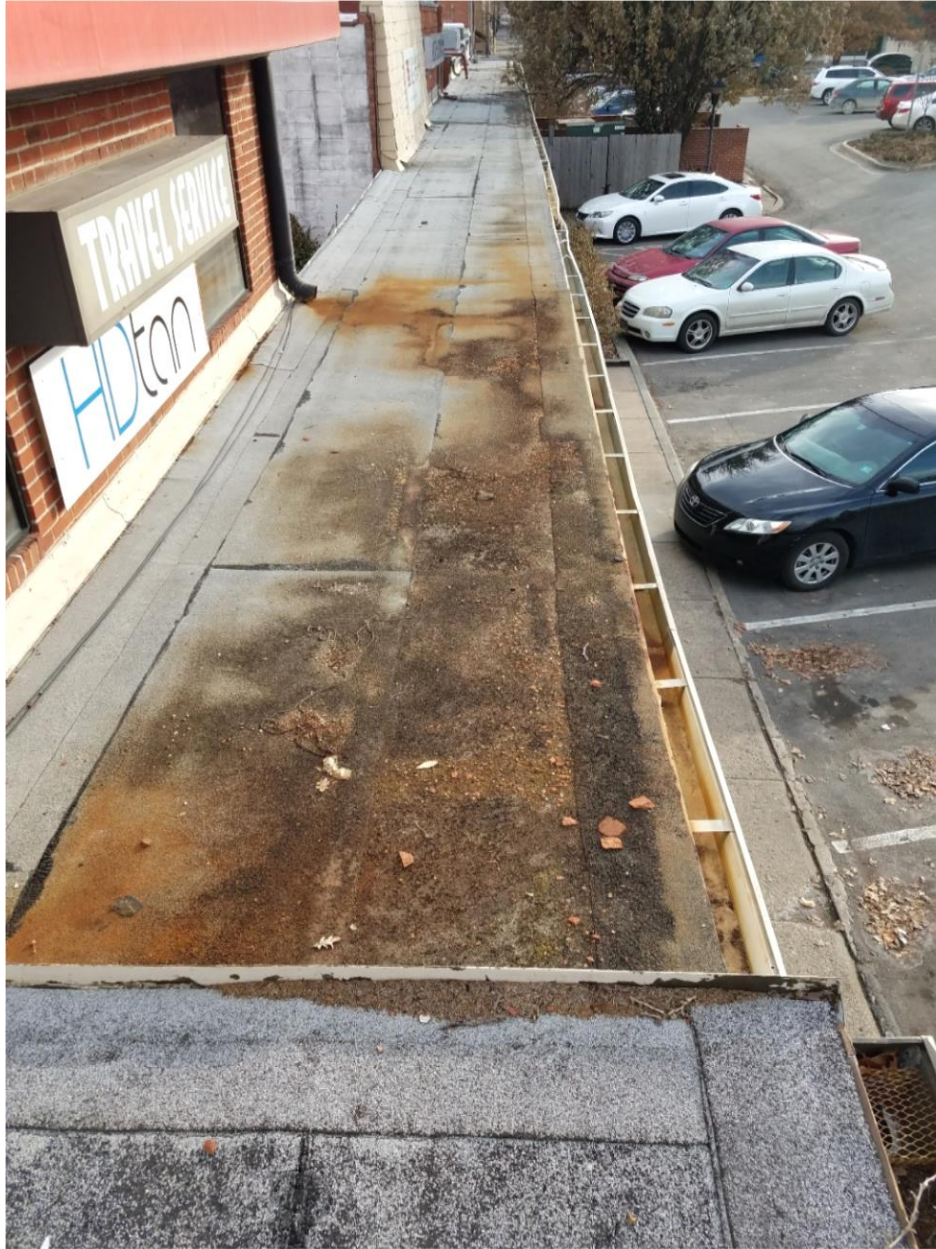
Typical roof section red stained areas indicate trapped water not shedding off into the gutters

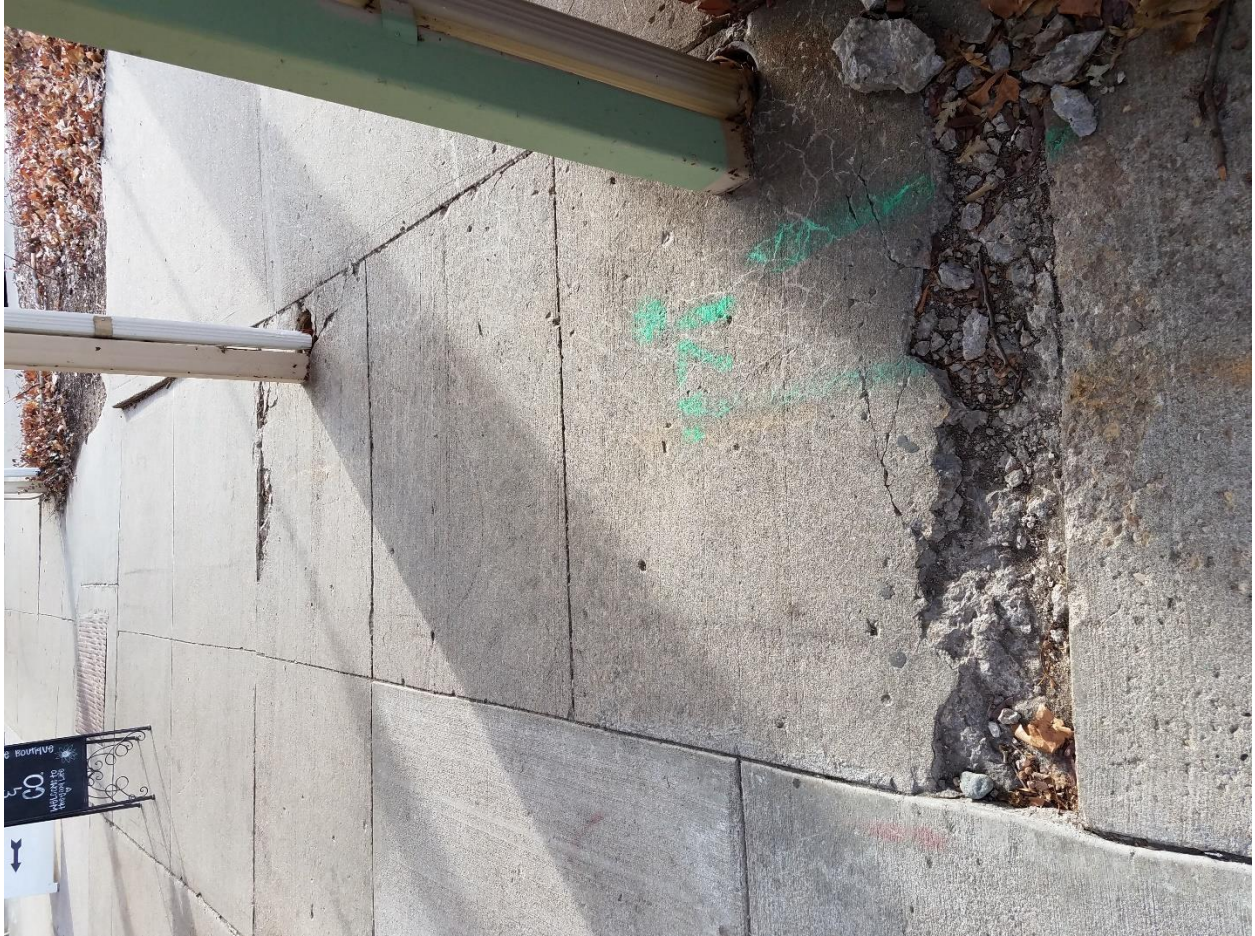
Typical concrete trip hazard and replacement issues (could not rotate picture, This is sidewalk under the canopy structure)
