# TRANSPORTATION CRASH ANALYSIS AND COUNTERMEASURE IDENTIFICATION

Developed for:  
**Lawrence - Douglas County**  
**Metropolitan Planning Organization**

Prepared by:  
**CFS Engineers**

**Approved by the MPO Policy Board: May 17, 2018**

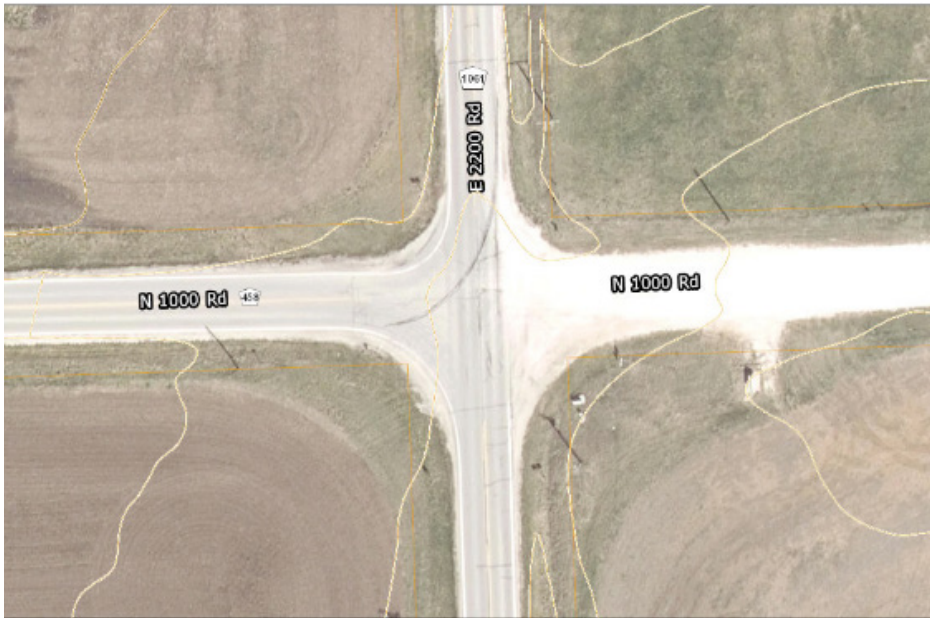
Figure 19: Overhead View of N 1000 Rd & E 2200 Rd

**Shoulder Surface Condition:** Poor, Damaged,  
Non-recoverable Rutting

**Roadside Conditions:** North Leg on West Side is Non-recoverable

**Site Observations:** During the safety audit, it was noted that the north-south lanes of E 2200 Rd had been recently overlaid accompanied with new pavement markings for the centerline and edge lines. N 1000 Rd to the east was gravel surface and approximately ten vehicles were observed using this roadway during the 45 minutes the safety team spent at the site which was more than expected

**Countermeasures:** Improvements include paving the east leg with asphalt to provide better traction for stopping vehicles, widening the shoulder and adding shoulder rumble strips to north and south legs, re-grading applicable steep sideslopes, adding an overhead light, adding stop bars and white edgelines to the east and west legs, installing intersection ahead warning signs to north and south legs, and adding an illuminated stop sign to the west leg. The cost of implementation is estimated at \$56,136 with a potential crash reduction benefit equivalent to \$76,205. The benefit : cost ratio is therefore 1.4 : 1.

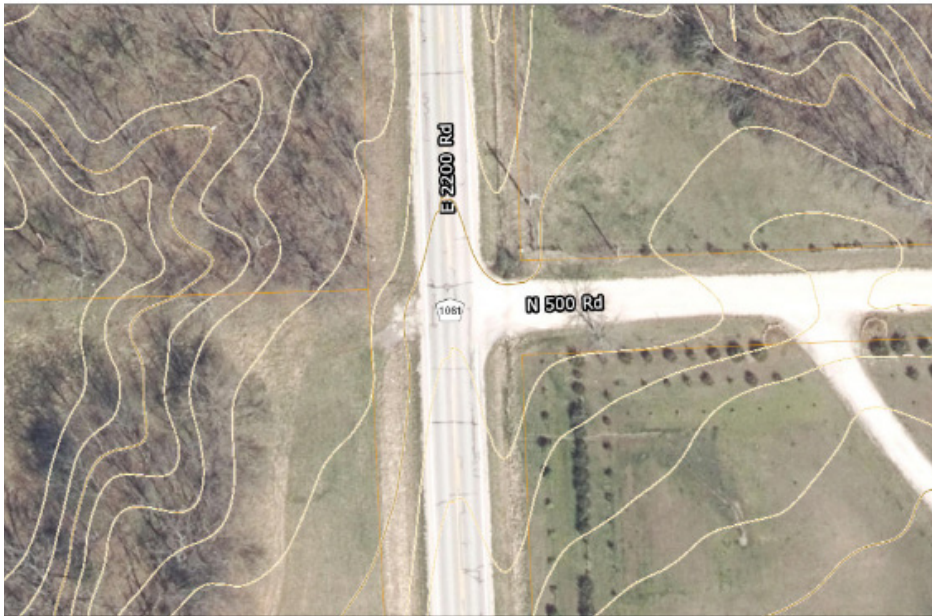
Figure 21: Overhead View of N 500 Rd & E 2200 Rd

**Shoulder Surface Condition:** Poor, Damaged,  
Non-recoverable Rutting

**Roadside Conditions:** Non-recoverable in Areas, Large  
Drop Off at Culvert

**Site Observations:** During the safety evaluation field  
inspection of the intersection, it was noted that the north  
and south legs of E 2200 Rd had been recently overlayed  
with new pavement and pavement markings for the  
centerline and edge lines. N 500 Rd to the east was gravel  
surface. The slopes of the roadside ditches along both the  
east and west sides of E 2200 Rd on both the north and

south approaches were not recoverable. The field on the northeast corner was fenced, the southeast corner was an private residential property, and the western side of the road was open field with a large, well-wooded creek meandering between 50 to 200 ft. away from E 2200 Rd. Deer tracks were readily observed along the southern side of N 500 Rd. Overhead power lines ran along the eastern side of E 2200 Rd, and along the northern side of N 500 Rd. There was a hill crest on E 2200 Rd to the south of the intersection which limited long-distance visibility of the intersection. Some wheel-ruts from errant vehicles leaving the roadway were observed on both sides of E 2200 Rd.

**Countermeasures:** Improvements include paving the east leg with asphalt to provide better traction for stopping vehicles, widening the shoulder and adding shoulder rumble strips to north and south legs, re-grading applicable steep sideslopes, adding an overhead light, adding a stop bar and white edgelines to the east leg, installation of object markers for the culvert drop-off, clearing overgrown vegetation, installing intersection ahead warning signs to north and south legs, and adding an illuminated stop sign to the east leg. The cost of implementation is estimated at \$49,570.67 with a potential crash reduction benefit equivalent to \$59,827. The benefit : cost ratio is therefore 1.2 : 1.

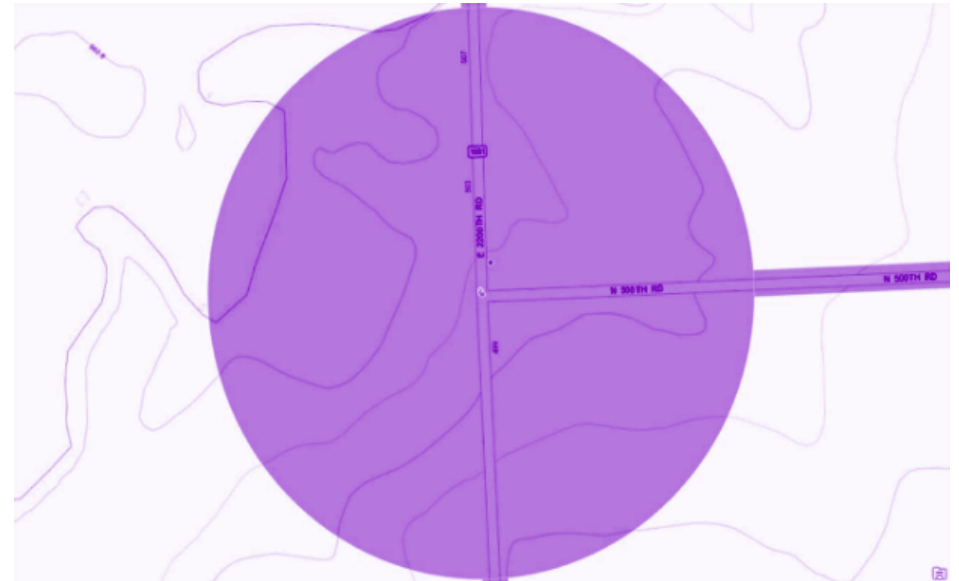
*Figure 22: Buffer Area and Crash Spot Locations at N 500 Rd & E 2200 Rd*

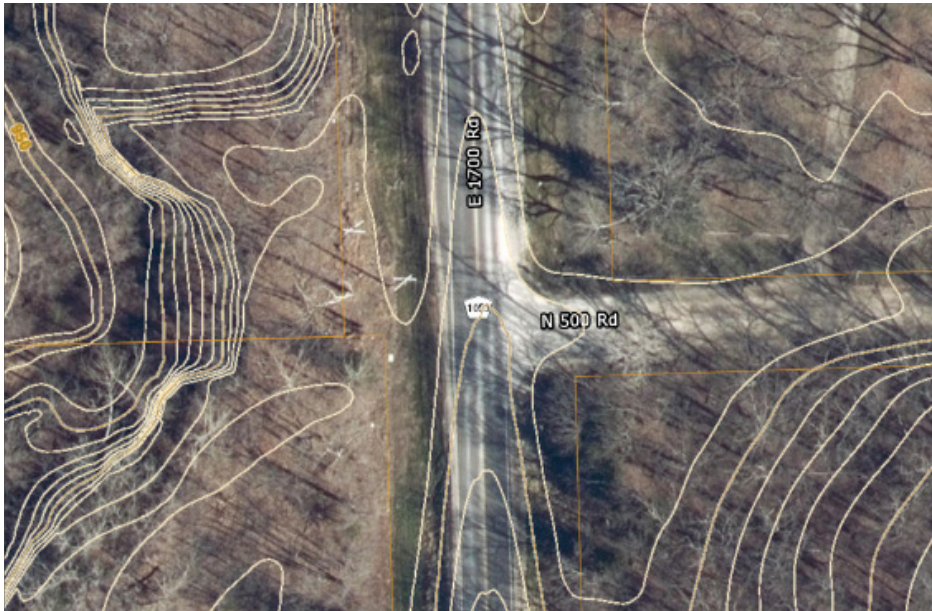
Figure 23: Overhead View of N 500 Rd & E 1700 Rd

**Shoulder Surface Condition:** Good, Non-recoverable  
Rutting on South Leg

**Roadside Conditions:** Non-recoverable in Areas, Large  
Drop Off at Culvert

long distance sight distance was inhibited. The northern approach of E 1700 Rd has widened paved shoulders on both sides that taper and at the south leg of the intersection. N 500 Rd is a gravel surface with an ascending slope for vehicles towards the intersection. During the field inspection, it was noted that about five lawn care trucks pulling equipment trailers were observed on N 500 Rd. There were overhead power lines along the western side of E 1700 Rd and along the south side of N 500 Rd.

**Countermeasures:** Improvements include paving the east leg with asphalt to provide better traction for stopping vehicles, widening the shoulder and adding shoulder rumble strips to north and south legs, re-grading applicable steep sideslopes, adding an overhead light, adding a stop bar and white edgelines to the east legs, installing intersection ahead warning signs to north and south legs, and adding an illuminated stop sign to the east leg. The cost of implementation is estimated at \$66,037.33 with a potential crash reduction benefit equivalent to \$71,890. The benefit : cost ratio is therefore 1.1 : 1.

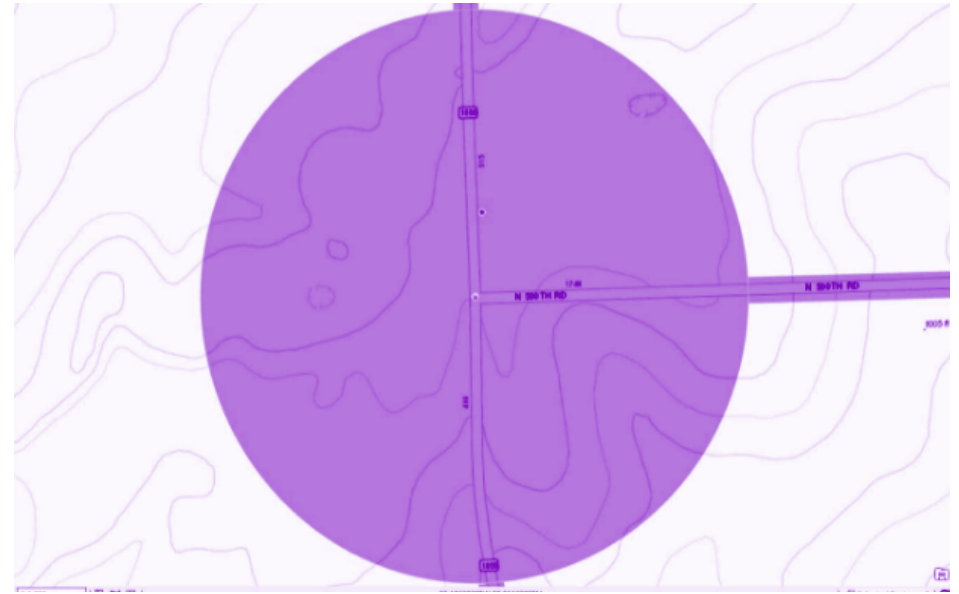
*Figure 24: Buffer Area and Crash Spot Locations at N 500 Rd & E 1700 Rd*

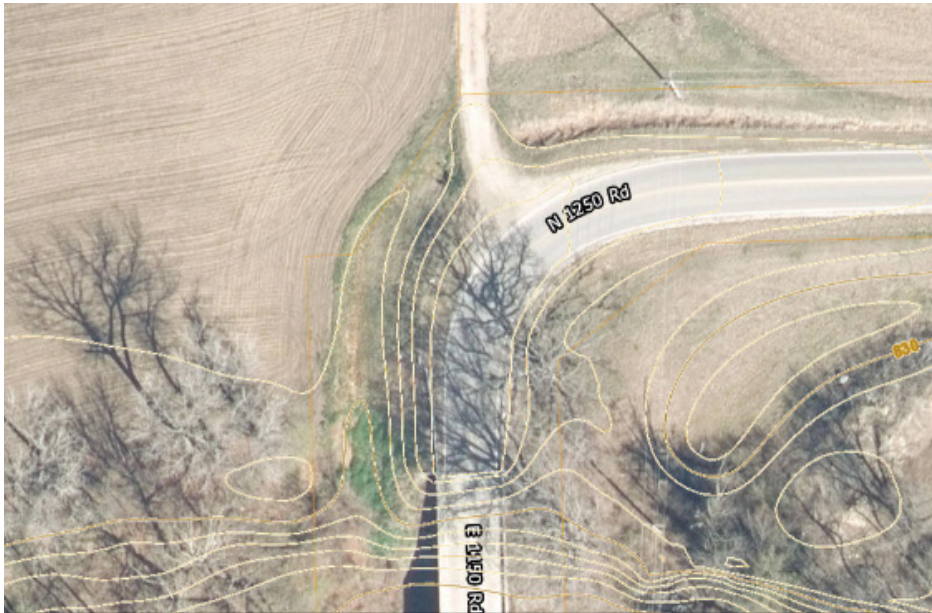
Figure 25: Overhead View of N 1250 Rd & E 1150 Rd

**Pavement Surface Condition:** Good Except Cracking at Transition to Bridge

**Shoulder Surface Condition:** Poor, Damaged, Non-recoverable Rutting

**Roadside Conditions:** Non-recoverable in Areas, Large Drop Off at Culvert

**Damage:** End of Guardrail, Signage

**Countermeasures:** Improvements include relocating the field access driveway away from the curve, repairing the asphalt at the bridge deck transition, widening the shoulder and adding shoulder rumble strips, centerlines rumble strips, and transverse rumble strips, re-grading applicable steep sideslopes, adding two overhead lights, re-striping pavement markings, extending the guardrail around the curve, and installing chevron signs. The cost of implementation is estimated at \$81,333.33 with a potential crash reduction benefit equivalent to \$132,020. The benefit : cost ratio is therefore 1.6 : 1.

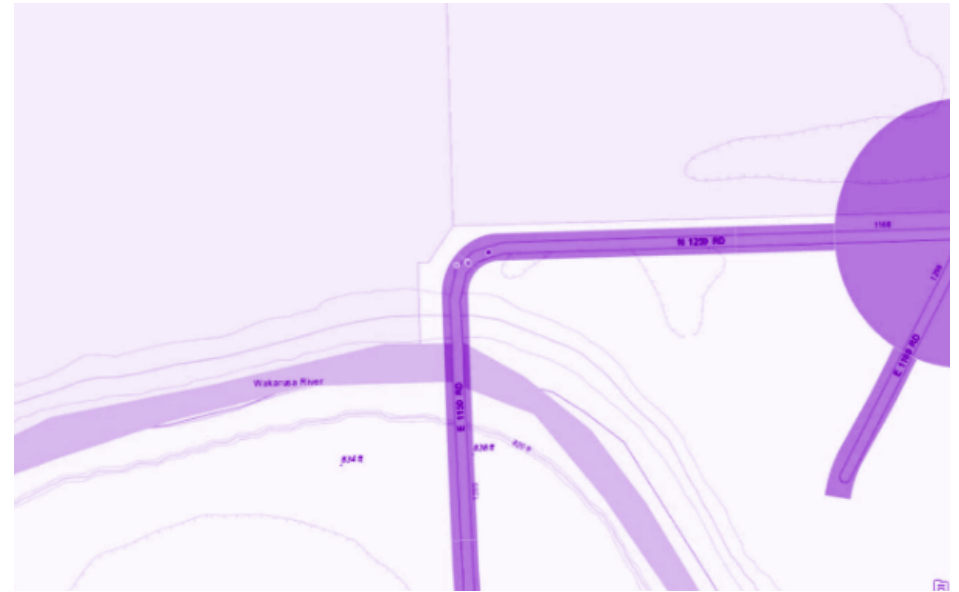
Figure 26: Buffer Area and Crash Spot Locations at N 1250 Rd & E 1150 Rd

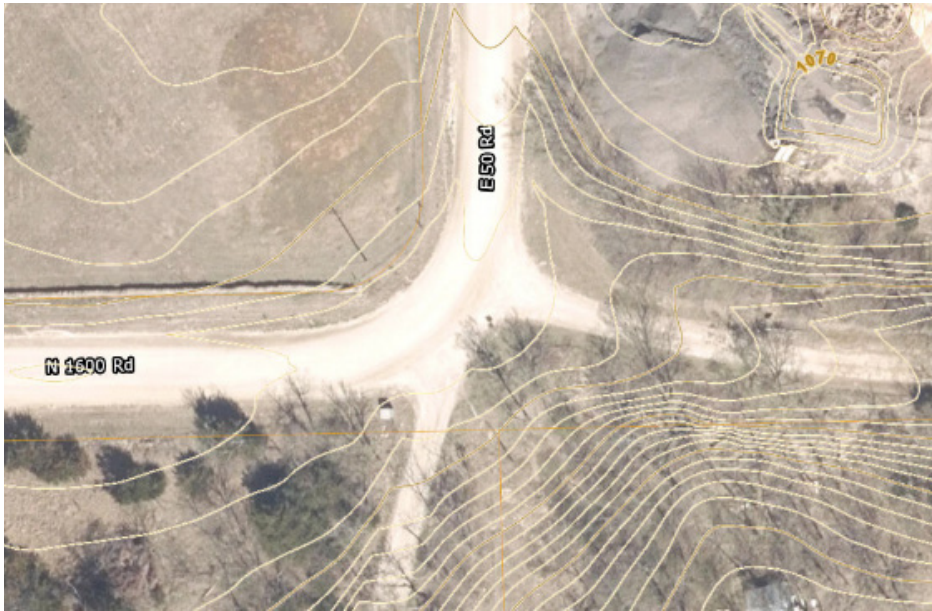
Figure 27: Overhead View of N 1600 Rd & E 50 Rd

**Pavement Surface Condition:** Poor

**Shoulder Surface Condition:** Poor

**Roadside Conditions:** Non-recoverable in Areas

**Damage:** Mailbox Dented

**Site Observations:** The L-shaped intersection is located approximately 450 ft. south of the intersection of E 50 Rd with Stull Road. The street is gravel surfaced, and the inspection crew noted several vehicles using the roadway during the field observation session. N 1600 Rd continues west to the Shawnee County Line where it becomes SE 53rd Street and is a paved roadway section. There is an abrupt vertical curve west of the intersection dropping steeply to the west, and it is likely that eastbound drivers gather speed to overcome the vertical crest curve. There

**Countermeasures:** Improvements include paving the curve with asphalt, widening the shoulder and adding shoulder rumble strips, centerlines rumble strips, and transverse rumble strips, re-grading applicable steep sideslopes, adding two overhead lights, re-striping pavement markings, installing chevron signs, and installing new curve ahead signs with speed advisory plaques. The cost of implementation is estimated at \$177,154.67 with a potential crash reduction benefit equivalent to \$70,686. The benefit : cost ratio is therefore 0.4 : 1.

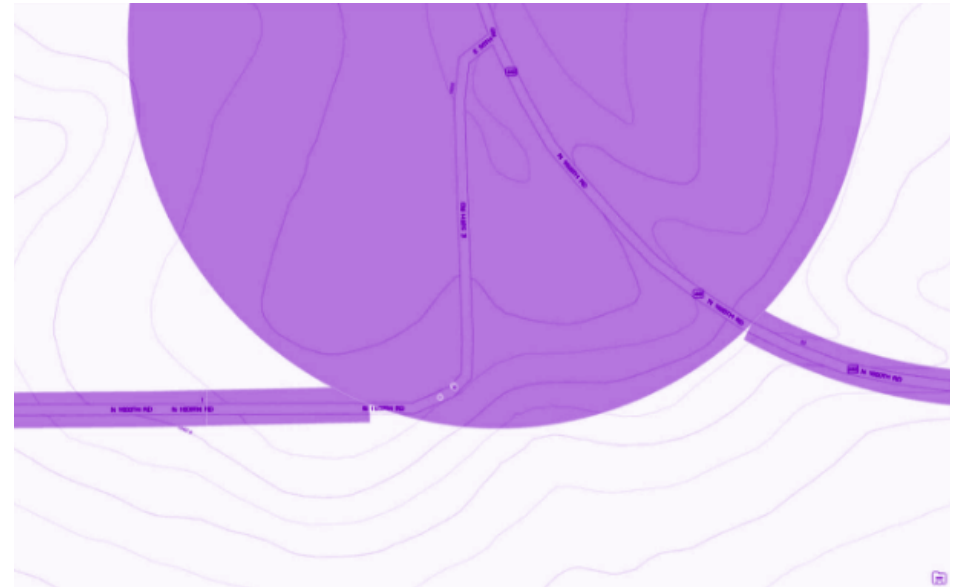
*Figure 28: Buffer Area and Crash Spot Locations at N 1600 Rd & E 50 Rd*

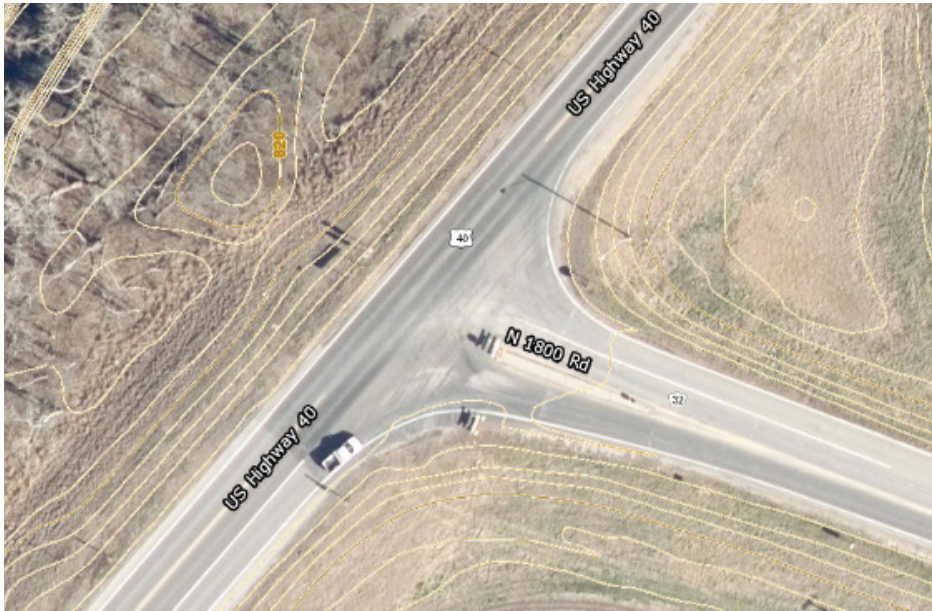
Figure 29: Overhead View of US-24/40 & K-32/Linwood Rd

**Countermeasures:** Improvements include repairing the existing raised median island, widening the shoulder and adding shoulder rumble strips, re-grading applicable steep sideslopes, adding right and left-turn arrow pavement markings, adding an additional overhead light to illuminate the median on the other side, adding an illuminated stop sign, and replacing the chevron signs at the far side of the t-intersection with a directional arrow. The cost of implementation is estimated at \$92,243.33 with a potential crash reduction benefit equivalent to \$104,606. The benefit : cost ratio is therefore 1.1 : 1.

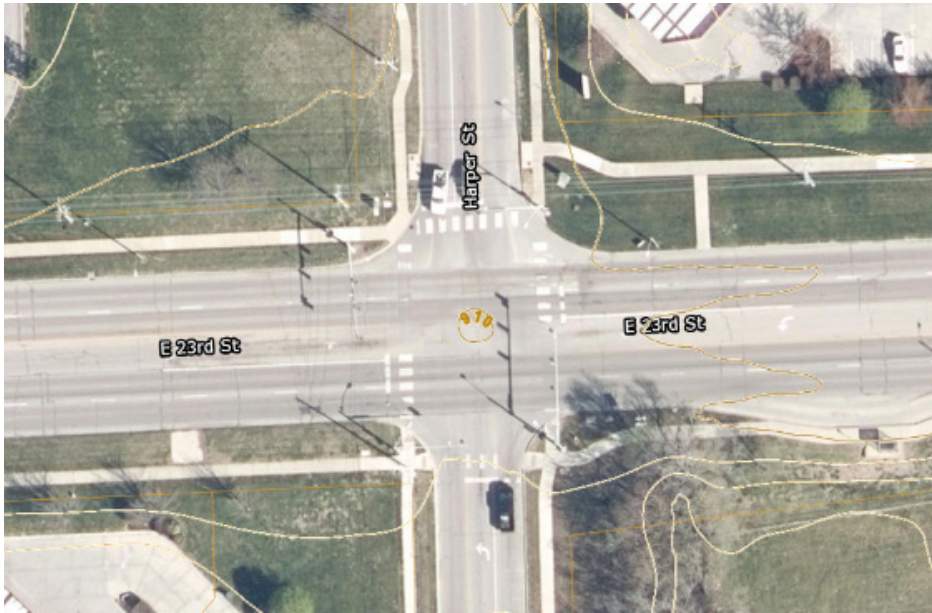
Figure 32: Overhead View of E 23rd St & Harper

**Countermeasures:** On 23rd St, the nearest driveway entrance was 350 ft. from the intersection, indicating that access management to eliminate or consolidate driveways would not be applicable. In the four years of crash data, only one crash involved turning maneuvers from any of the nearby access driveways. Adding a right-turn auxiliary lane was not recommended as a safety measure to help alleviate any the rear-end crashes recorded at the intersection. A typical year had only one crash that could have been prevented by construction of an eastbound or westbound right-turn lane. The improvements recommended for the intersection were basic housekeeping measures that included replacing the non-ADA-compliant sidewalk ramps at the NE and NW corners and re-marking the faded pavement markings at the intersection. The detailed analysis did not indicate any special accommodations were needed for bikes or buses due to the low number of crashes. The estimated cost for the improvements is \$7,000.

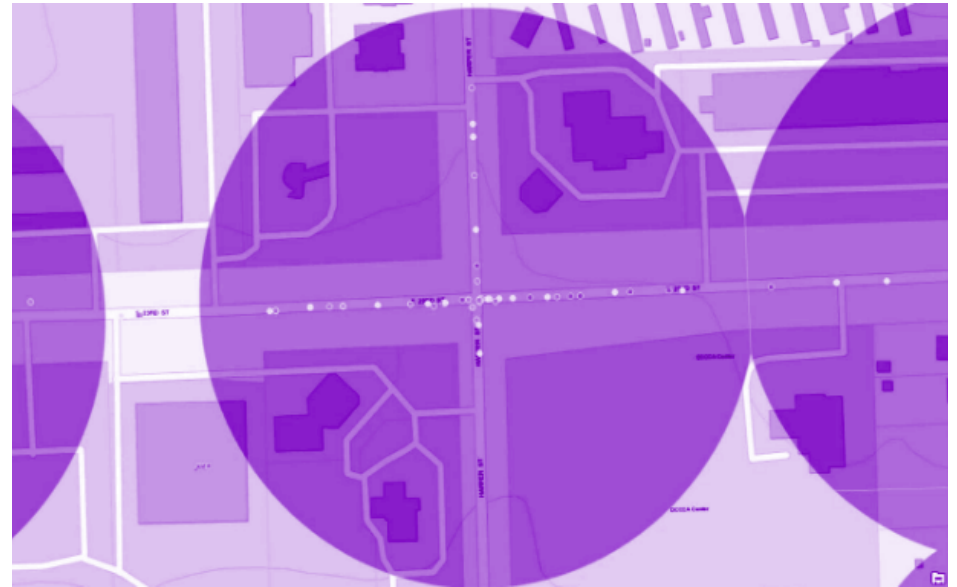
*Figure 33: Buffer Area and Crash Spot Locations at E 23rd St & Harper*

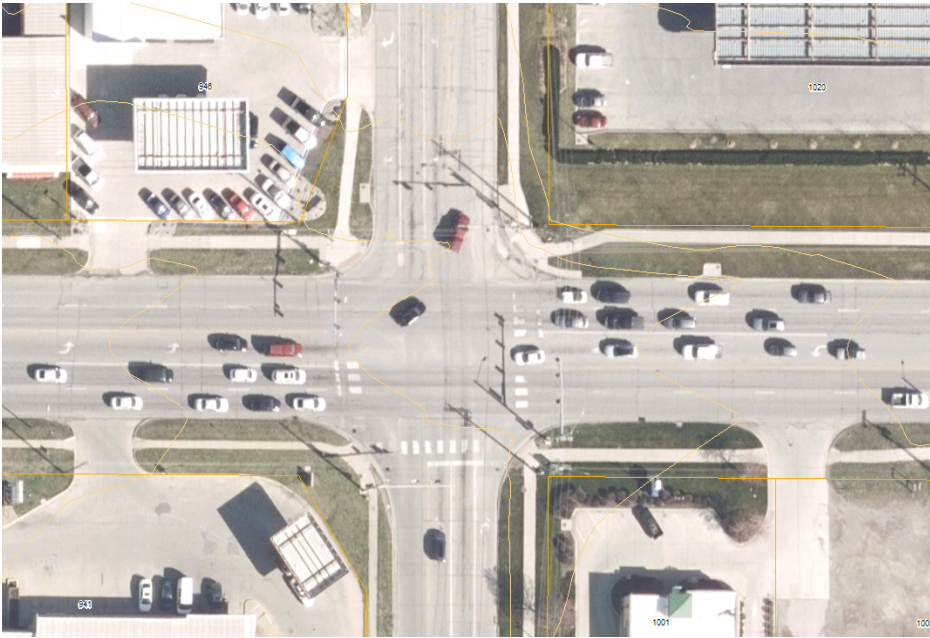
Figure 34: Overhead View of E 23rd St & Haskell

**Countermeasures:** On 23rd St, there were three driveway entrances on the northwest, southwest, and southeast quadrants, all located approximately 170 ft. from the intersection. The intersection is located along the commercialized segment of 23rd St where driveways on both sides of the street are frequent and relatively closely spaced. Access management to eliminate or consolidate driveways would be practical considering that, in the four years of crash data, several crashes involved turning maneuvers from the nearby access driveways. Along the west leg, approximately six crashes involved the access driveway for 800 E 23rd St. Along the east leg, approximately six crashes involved the access driveway for 1003 E 23rd St. The QuikTrip and Sonic driveways had a combined six crashes. All of these driveways are recommended to be changed to a left-in, right-in, right-out configuration because most crashes were left-out

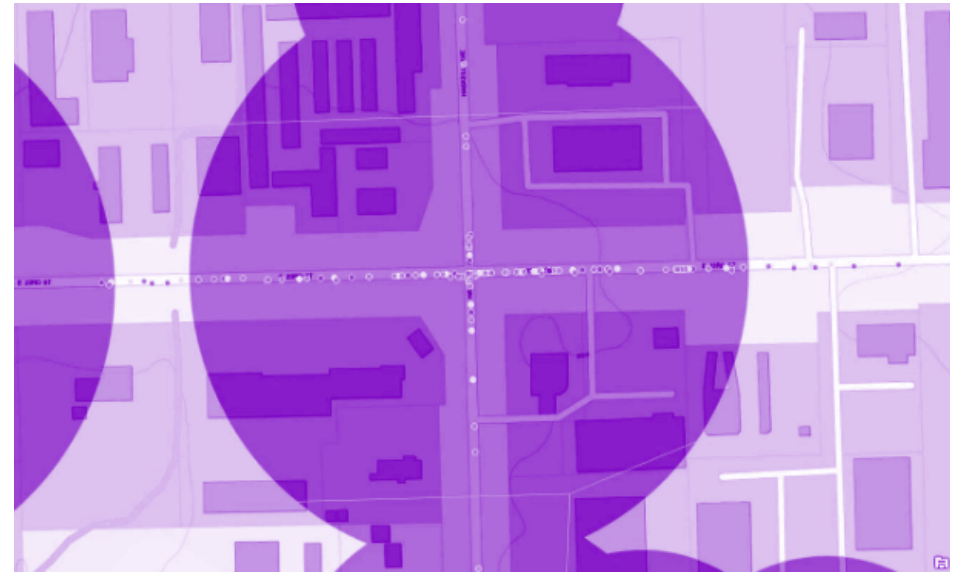
*Figure 35: Buffer Area and Crash Spot Locations at E 23rd St & Haskell*

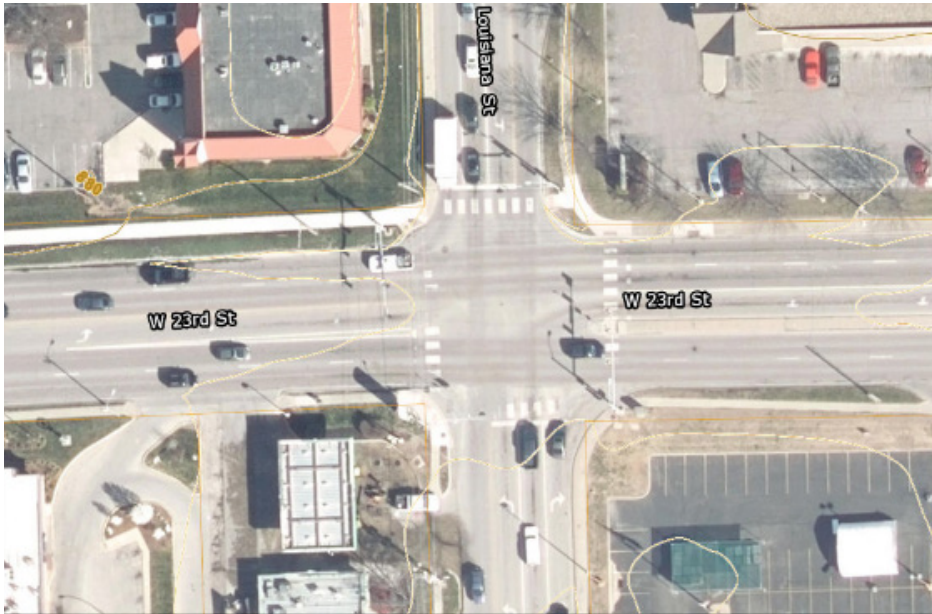
Figure 36: Overhead View of E 23rd St & Louisiana

**Countermeasures:** The surrounding street frontage on both sides of 23rd St are heavily commercialized, and driveways are very closely spaced. It is recommended to close and consolidate the entrance into the British Petroleum station on the south leg of Louisiana with the next intersection to the south. The existing driveway entrance is only 60 ft. south of the 23rd St intersection and is a potential source of crashes for eastbound motorists making left-turns or westbound motorists making right-turns onto the southern leg of Louisiana. Along the west leg, four crashes involved the access driveway for the BP station. This driveway is recommended to be changed to a right-in, right-out configuration due to the proximity of the intersection. Adding a right-turn auxiliary lane was not recommended as a safety measure to help alleviate any the rear-end crashes recorded at the intersection. A typical year had only one crash that could have been

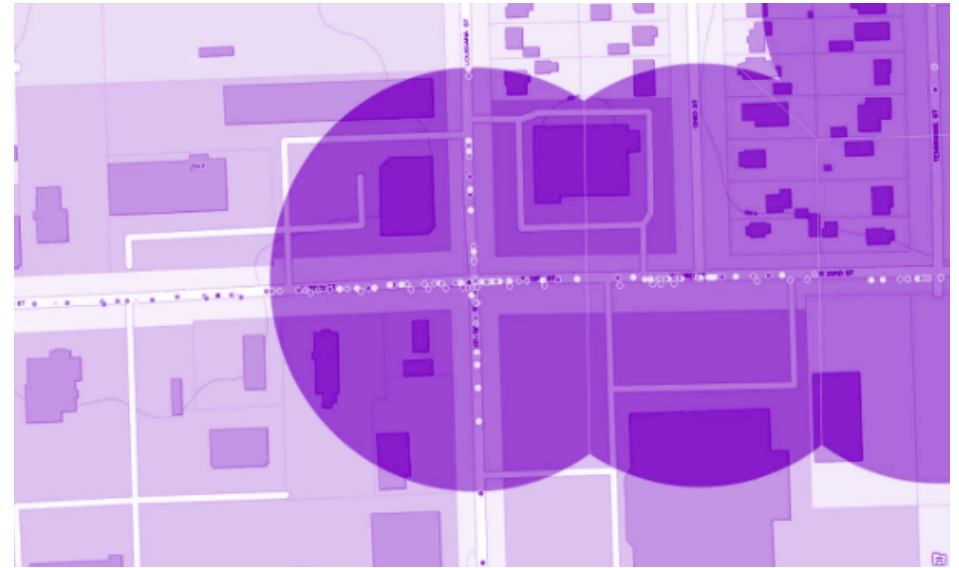
*Figure 37: Buffer Area and Crash Spot Locations at W 23rd St & Louisiana*

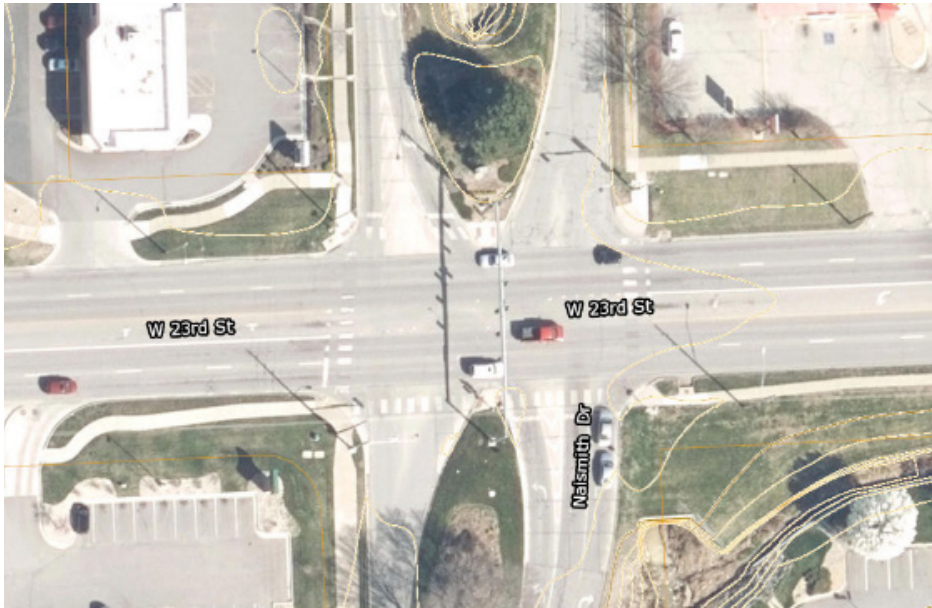
Figure 38: Overhead View of E 23rd St & Naismith

**Countermeasures:** On 23rd St, the nearest driveway entrance was 100 ft. from the intersection, indicating that access management to eliminate or consolidate driveways is applicable. Access management to change the driveways at the southwest corner to a left-in, right-in, right-out configuration was completed in 2012. The access driveway on 23rd St in the northwest corner should also be changed to a left-in, right-in, right-out configuration. Adding a right-turn auxiliary lane was not recommended as a safety measure to help alleviate any the rear-end crashes recorded at the intersection due to the low number of applicable crashes. The improvements recommended for the intersection included re-marking the faded pavement markings at the intersection. The detailed analysis did not indicate any special accommodations were needed for bikes or buses due to the low number of crashes. The estimated cost for the improvements is \$4,000.

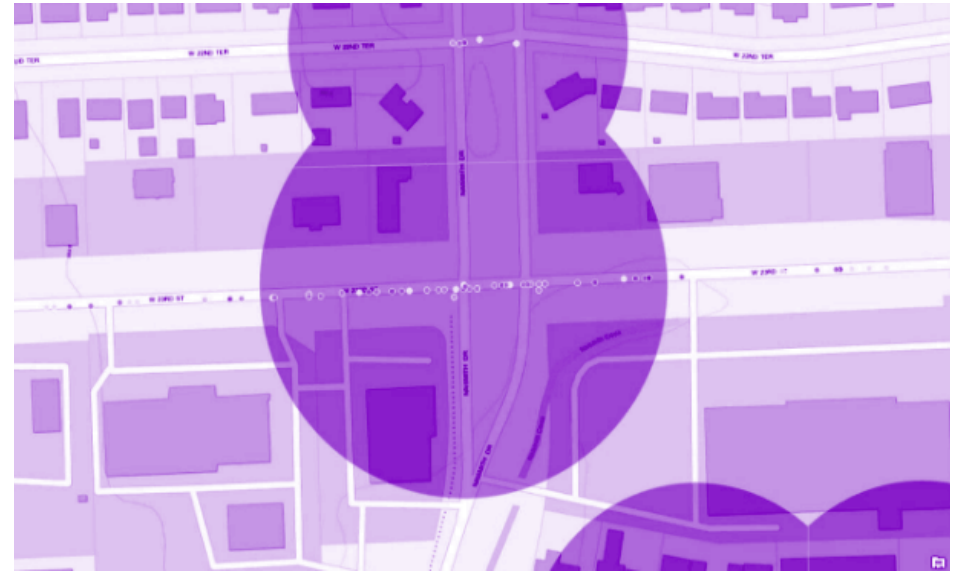
*Figure 39: Buffer Area and Crash Spot Locations at E 23rd St & Naismith*

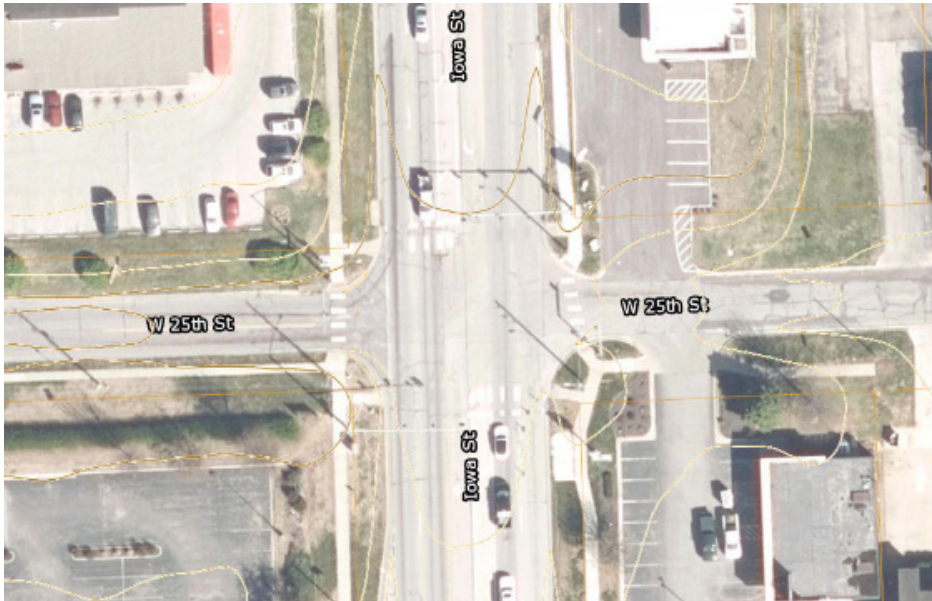
Figure 40: Overhead View of W 25th St & Iowa

**Countermeasures:** The closest driveway along Iowa in the northeast corner was approximately 130 ft. to the intersection with W 25th St. The next driveway is approximately 25 ft. to the north. Due to the proximity of these driveways to the intersection, the recommendation is to change the driveways to a left-in, right-in, right-out configuration. In the four years of crash data, about two crashes involved turning maneuvers from each of the nearby access driveways indicating that access management to eliminate or consolidate driveways would be applicable. The City installed a narrow median barrier between the opposing driveways on the east leg on W 25th St that should be painted a bright yellow and the damaged safety reflectors replaced. Adding a right-turn auxiliary lane was not recommended as a safety measure to help alleviate any crashes since a typical year had only one crash that could have been prevented by construction of

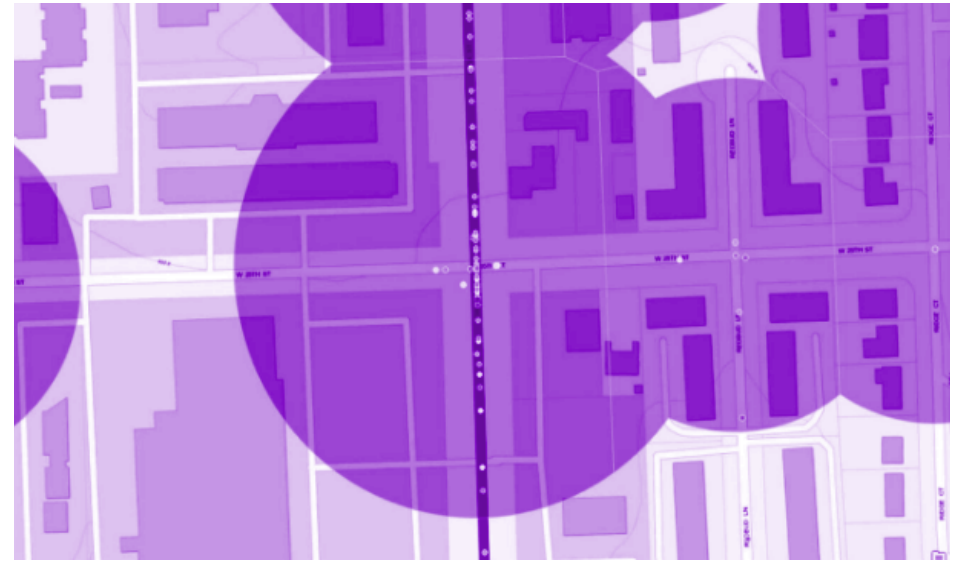
*Figure 41: Buffer Area and Crash Spot Locations at W 25th St & Iowa*

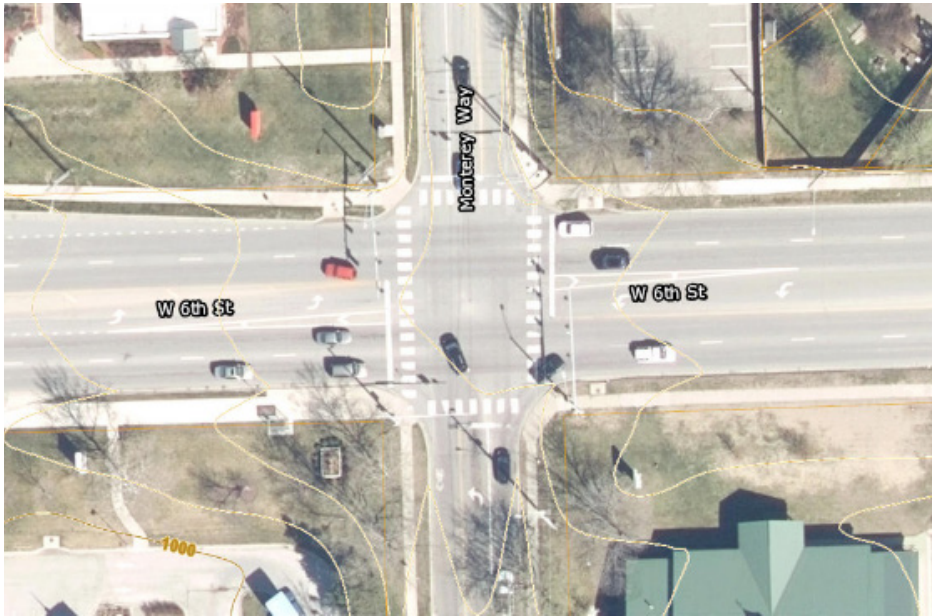
Figure 40: Overhead View of W 6th St & Monterey Way

**Countermeasures:** This area of western Lawrence was recently developed, and the driveways along 6th St are well spaced from the intersections. In the four years of crash data, only one crash involved turning maneuvers from any of the nearby access driveways. Adding a right-turn auxiliary lane was not recommended as a safety measure to help alleviate any crashes. A typical year had only two crashes that could have been prevented by construction of an eastbound or westbound right-turn lane. Adding right-turn auxiliary lanes was recommended as a safety measure to help alleviate some of the rear-end crashes recorded at the intersection and to improve traffic operations. A typical year had two crashes that could have been prevented by construction of a westbound right-turn lane and two crashes that could have been prevented by construction of an eastbound right-turn lane. The existing sidewalk ramps on the northwest, southwest, and southeast corners are non-
