Project UT1202 Kaw Water Treatment Plant Traveling Water Screen Rehabilitation

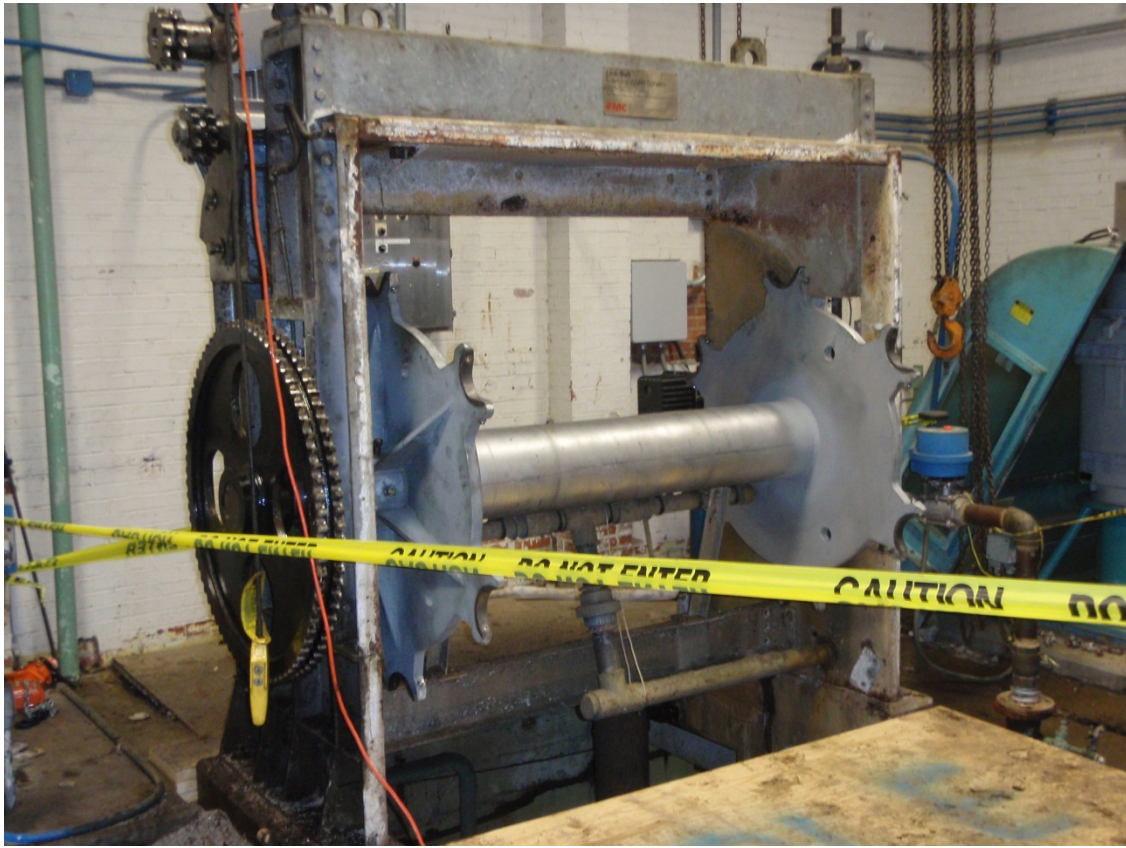
Traveling water screen head unit with new torque tube and chain sprockets installed.

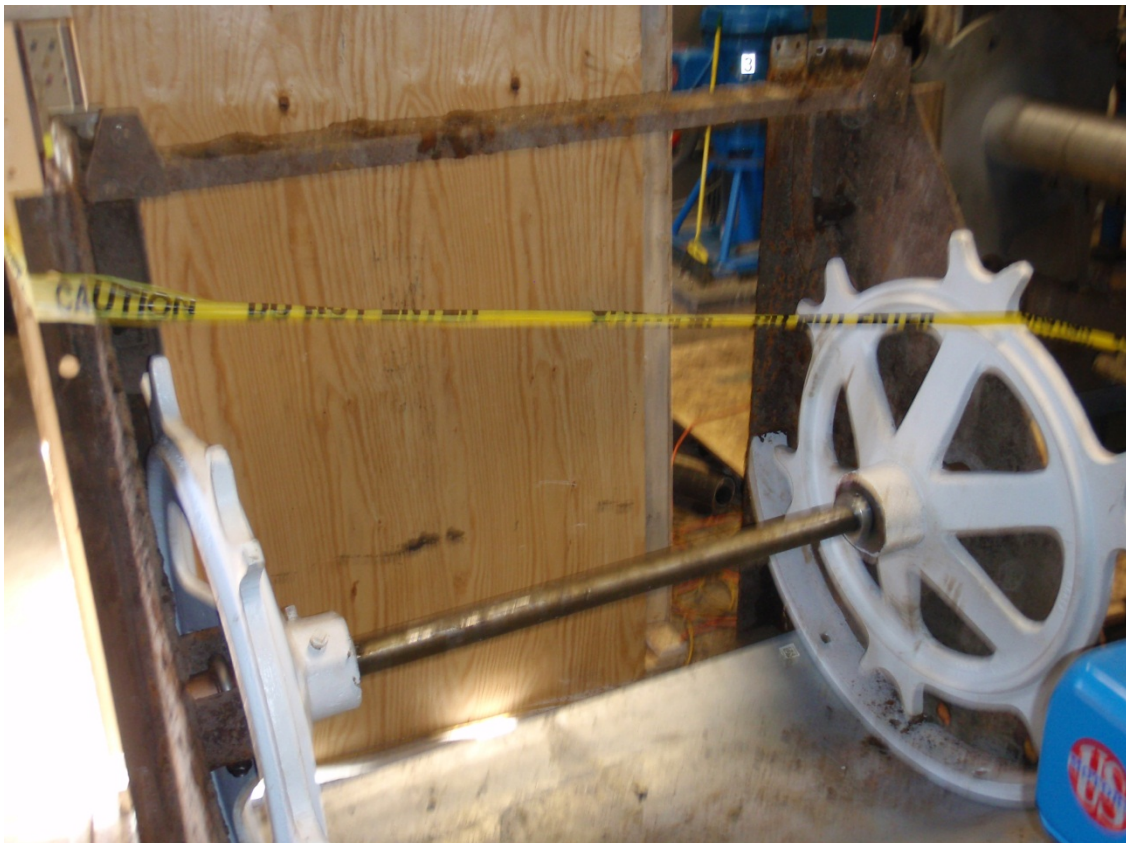
Boot section with new lower chain sprockets and bushings installed

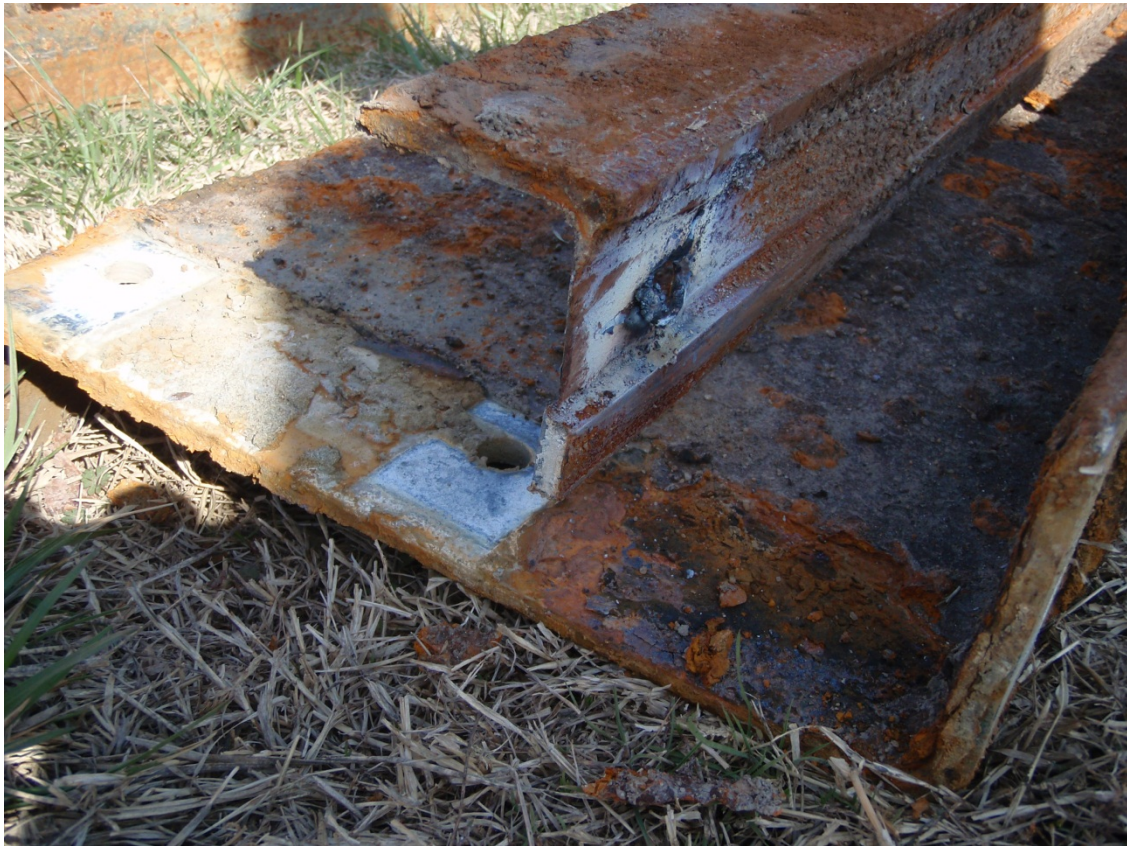
Corroded and worn intermediate frame rail and chain guide

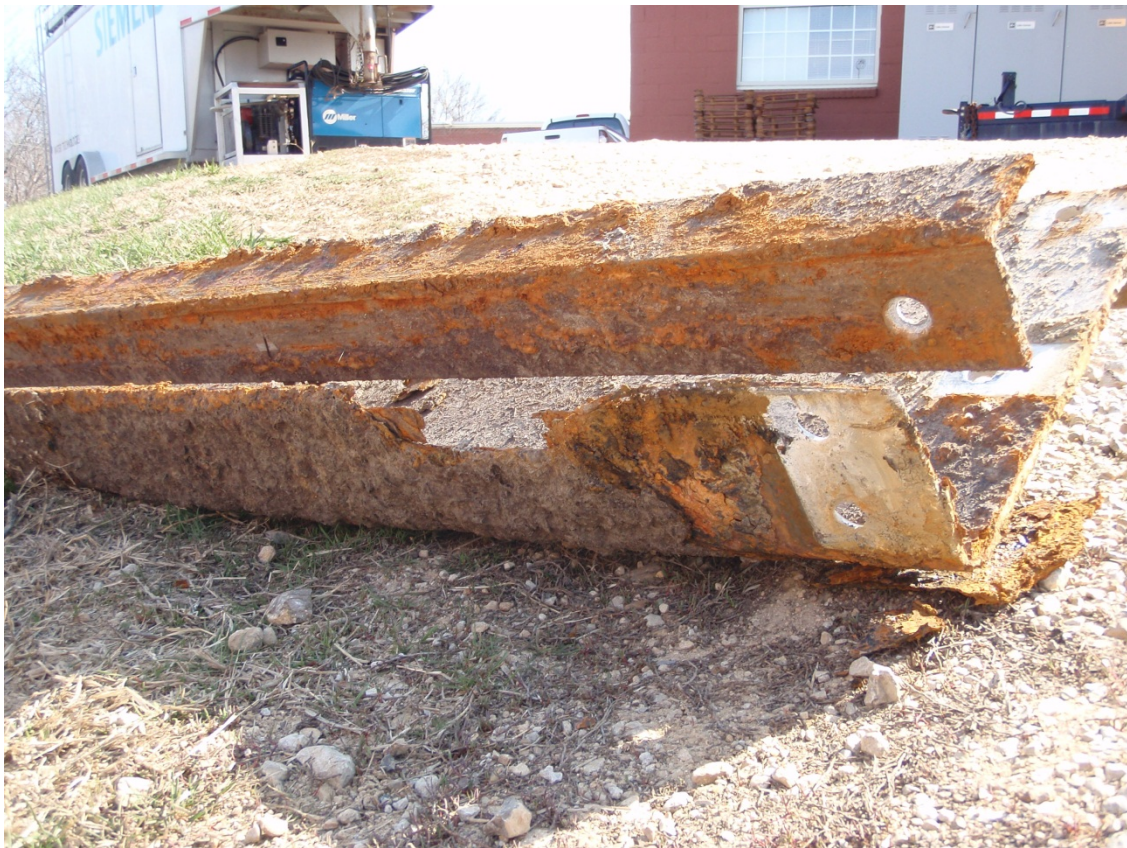
Corroded intermediate frame rail
